Montgomery County Fire and Rescue Service

Post Incident Analysis

Fatal Building Fire
415 Silver Spring Ave.
Silver Spring, MD

Incident Date: April 2, 2013
Incident # 13-0035730

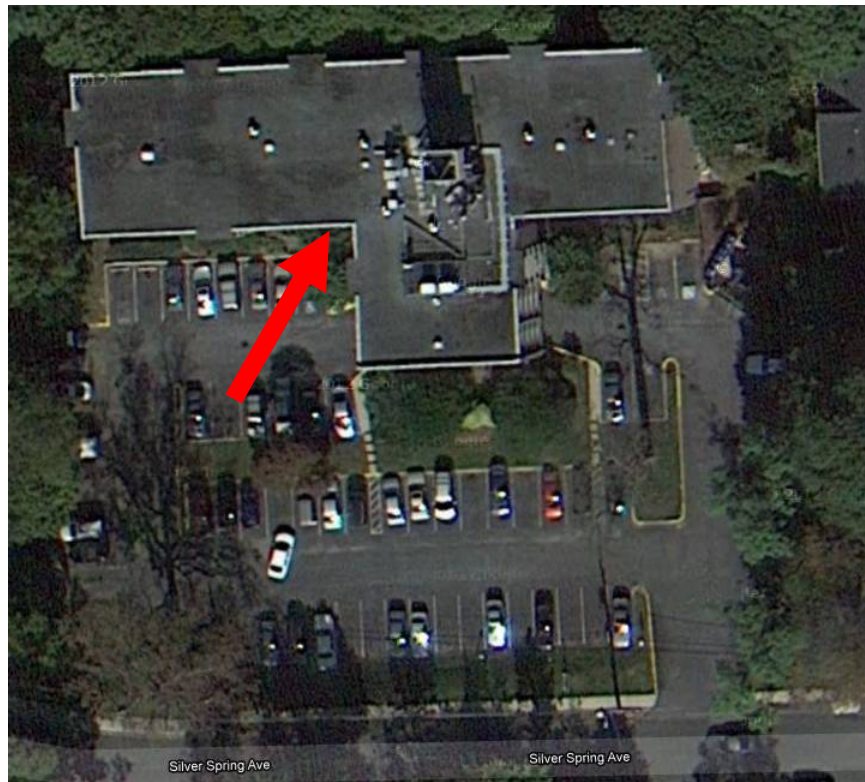
Arrow points to location of the fire apartment on the top floor

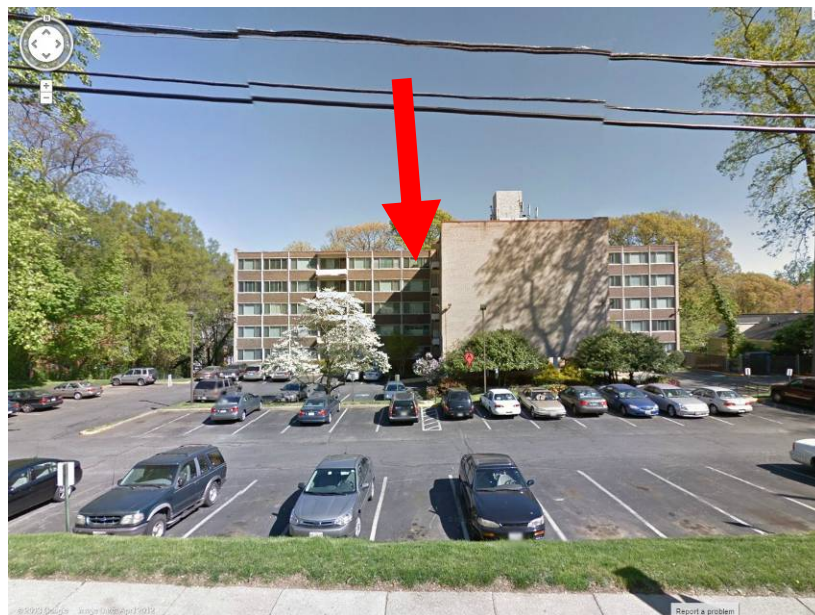
Side Alpha view arrow shows location of the fire apartment

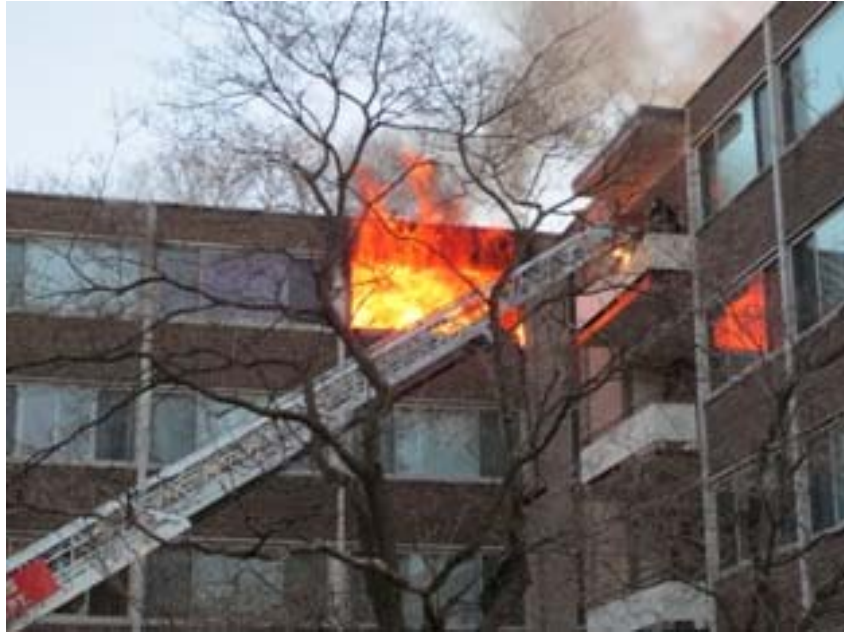
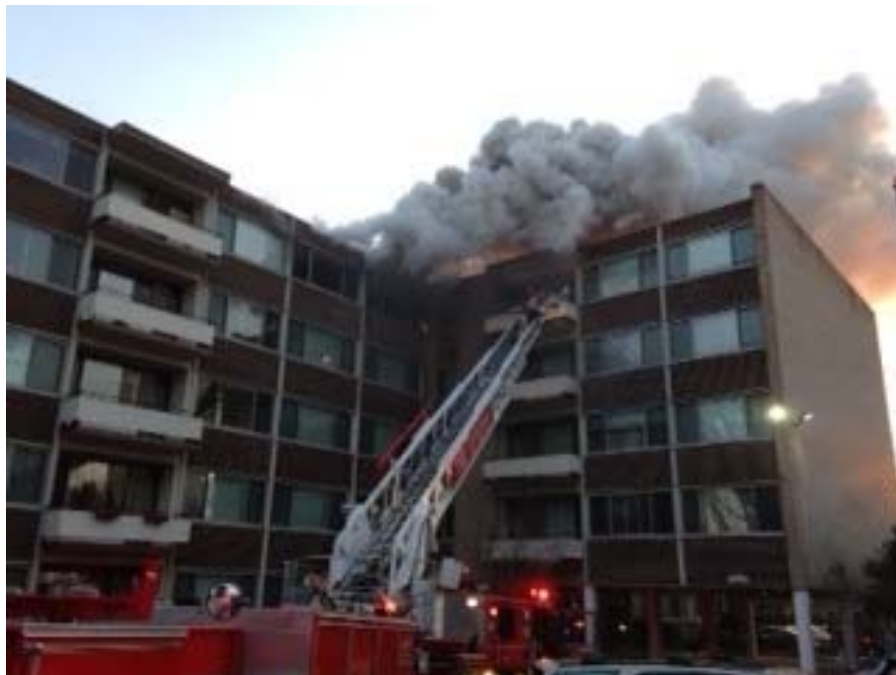
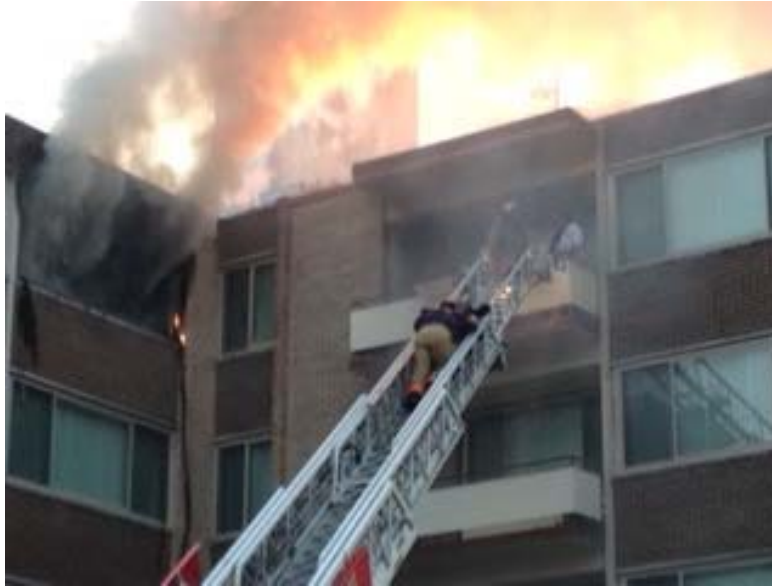
Damage to the building was extensive, with the fire apartment 100% involved and with fire having vented to the exterior. Further thermal and smoke damage was sustained to the common hallway as crews entered the apartment. The total dollar loss for the structure and the contents was \$400,000.00.

The following pictures show conditions on arrival through extinguishment:

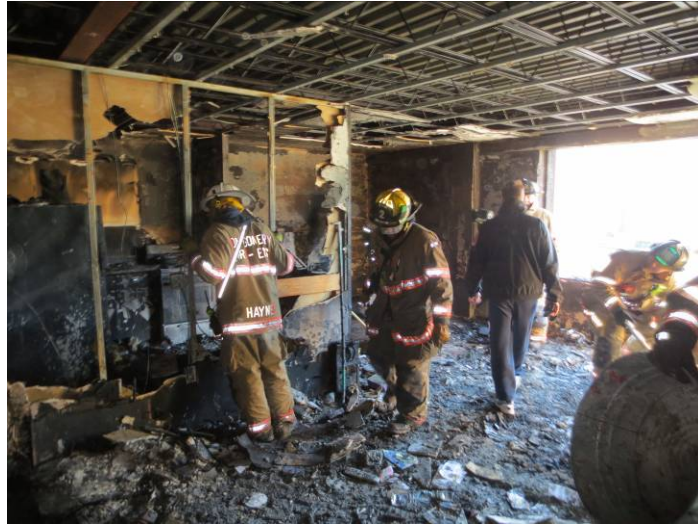
- Due to extensive fire damage it was difficult to pinpoint where the fire started or the cause of it. The entire contents of the apartment were almost entirely burned. The Fire and Explosive Investigator determined that the fire was accidental and the case was closed.

Interior view of the fire apartment

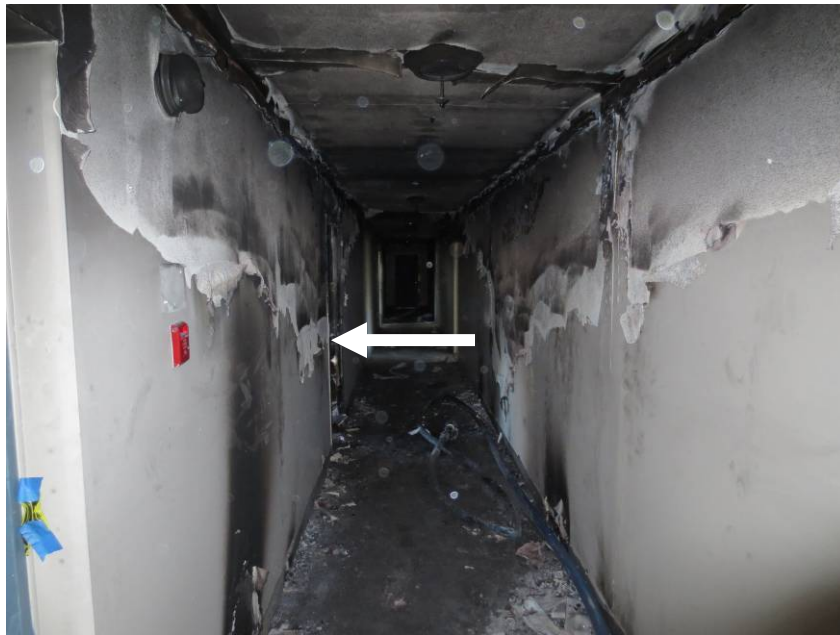
View from the sixth floor hallway. Arrow shows the door to the fire apartment. Note the signs of high heat that was encountered by the first in crews.

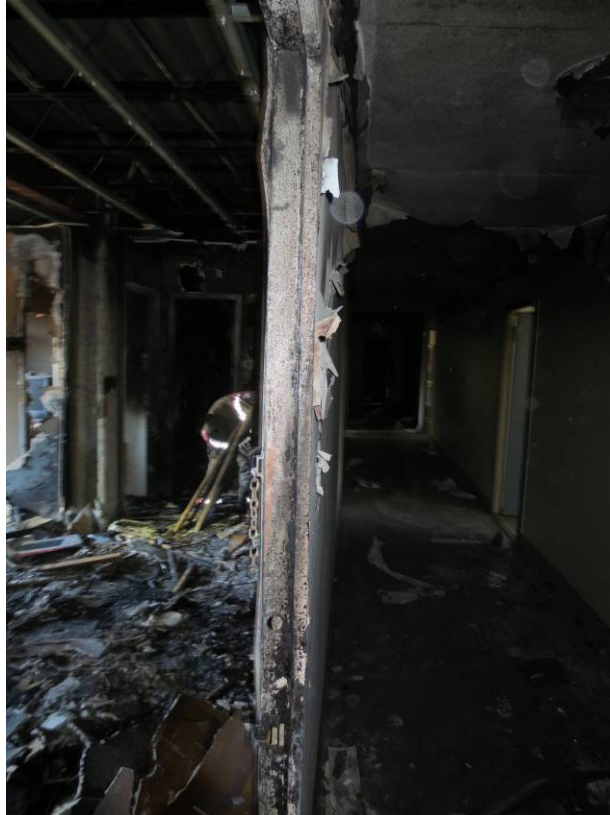
View of the fire apartment door frame. The wall separating the fire apartment and the common hallway was 3 sheets of drywall. There were no studs or frame work holding up the entire length of the wall.
